T10/03-380r1

Subject
ADT Baud Rate Fallback

Date
29 October, 2003

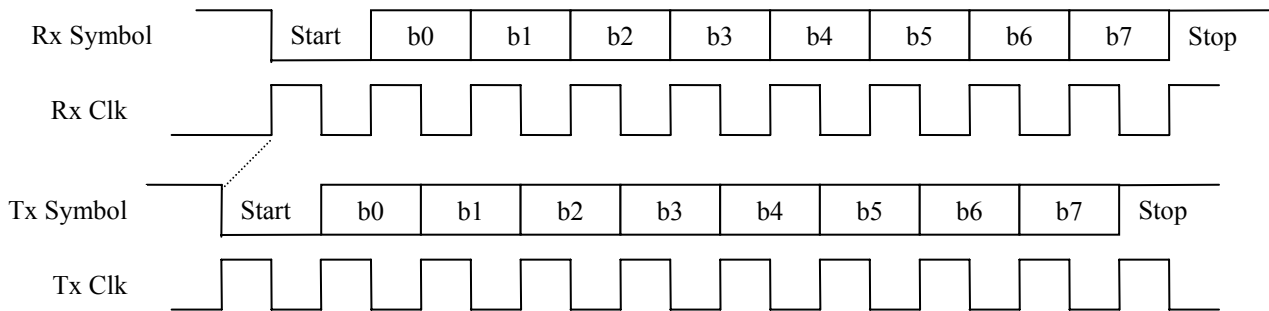
Figure 1 shows the clock relationship between a transmitting and receiving port under normal operation.

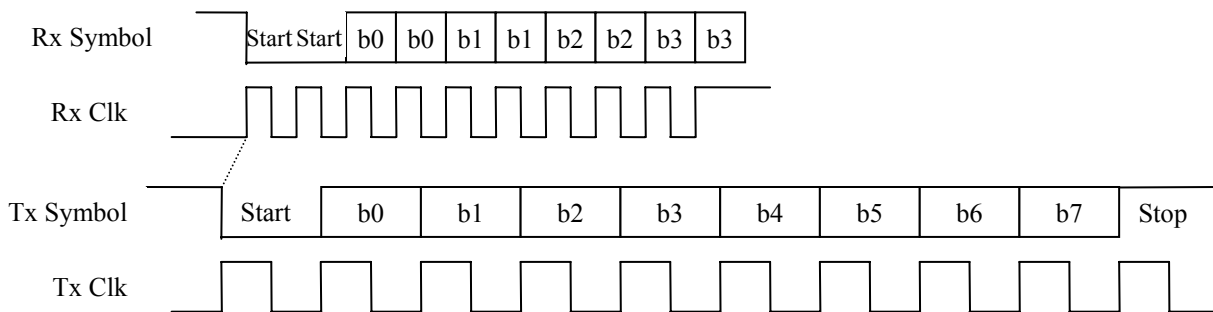
Figure 2 shows the clock relationship between a transmitting and receiving port when the receiving baud rate exceeds the transmitting baud rate by a factor of two.

If the transmitter sends an SOF (5Bh) with a one bit gap before the next byte, the receiver running at twice the baud rate may receive 19h, 7Fh:
