Dick Uber
Quantum
May 1998

HOT SWAP TECHNICAL ISSUES

Hot insertion data has been taken on an LVD backplane. A variety of hot swap events with accompanying photos is presented.

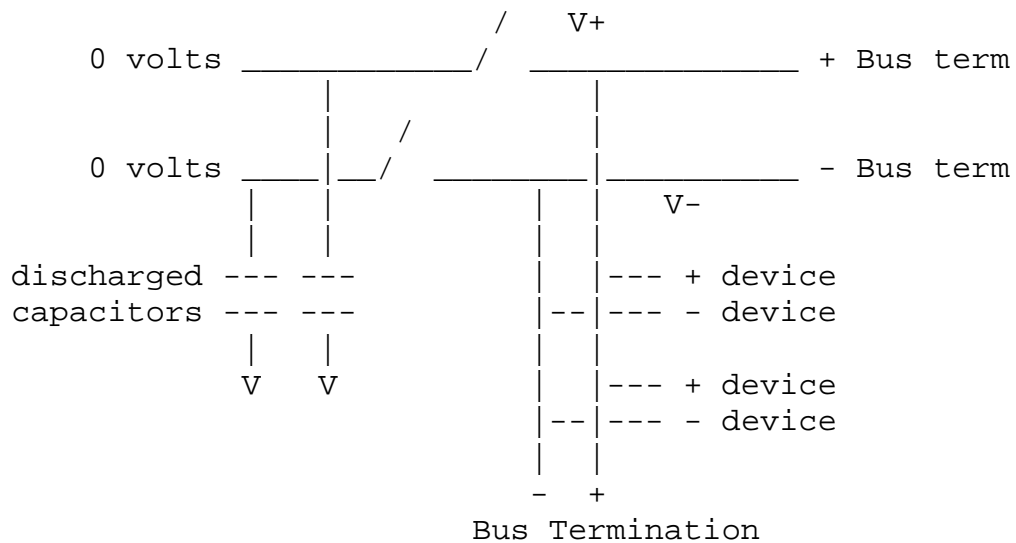
SEQUENCES FOR PIN MATING

There are 4 possible mating events:

- 1 Mating to more positive line, with more negative line connected.
- 2 Mating to more positive line, with more negative line floating.
- 3 Mating to more negative line, with more positive line connected.
- 4 Mating to more negative line, with more positive line floating.

In cases 1 and 2, a really large transient can cause a reversal of the logical state of the bus.

In all 4 cases, a hot swap event can cause a timing shift of transitions on the bus.

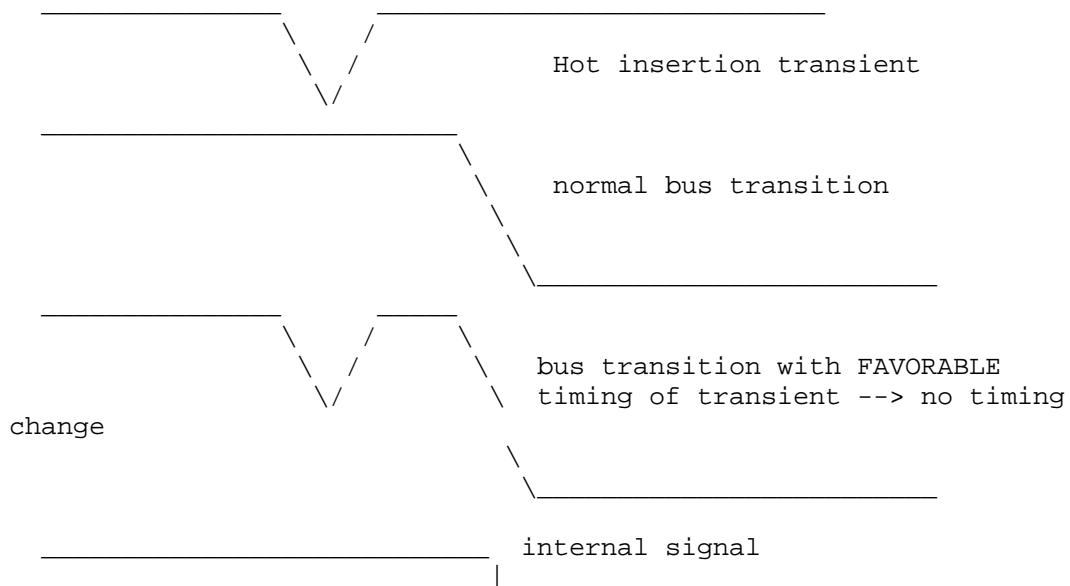
Less Severe glitch:

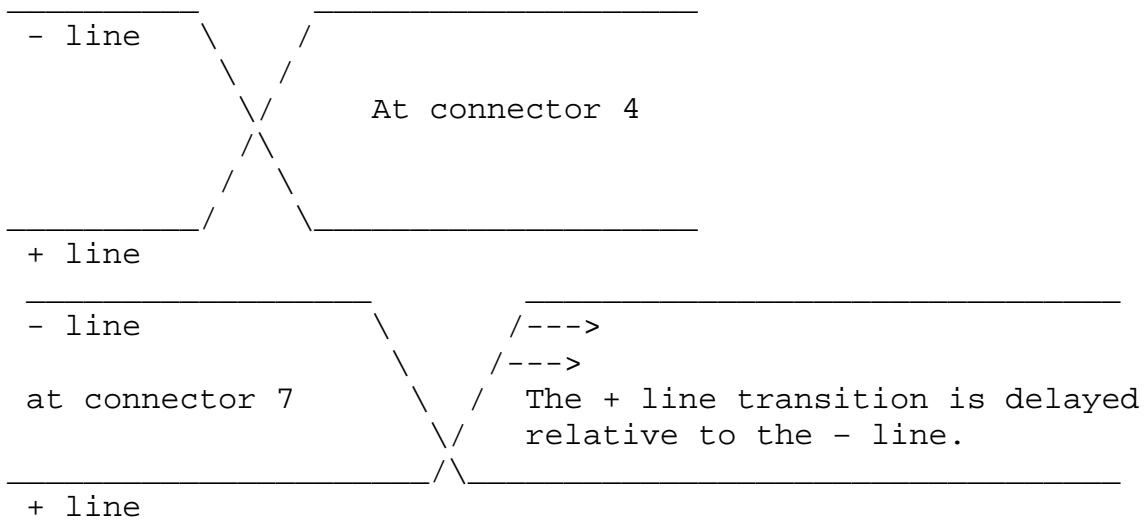
Backplane with balanced loads. Signals being observed are the ACK lines on a backplane separated from the host by a 2 meter ribbon cable.
