Explanation of Plots

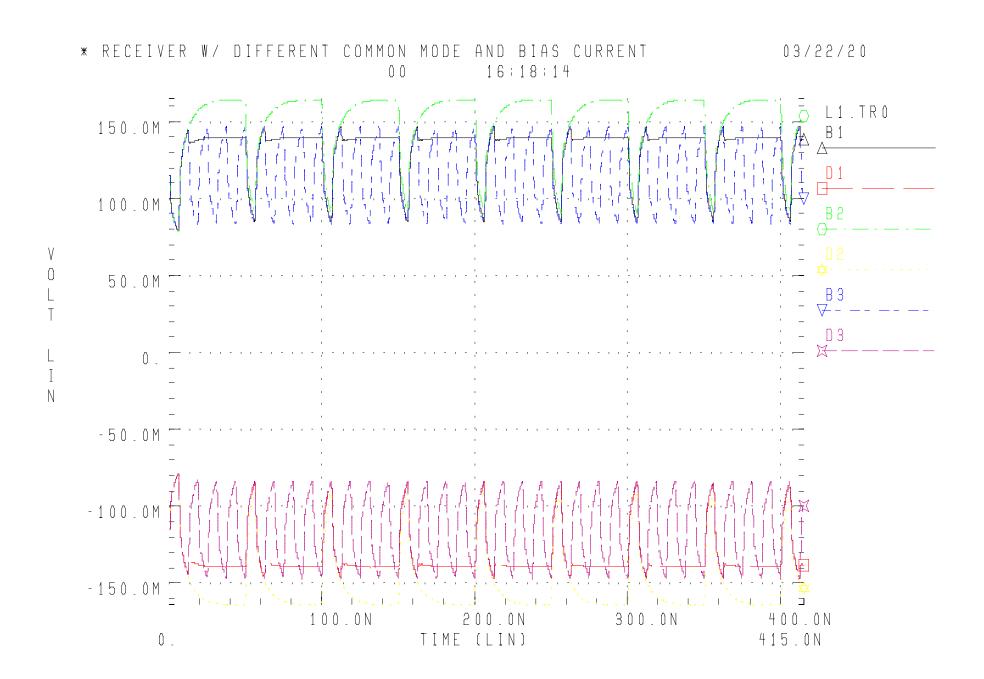
Plot L1.1

- L1.1 shows the plus & the minus signals instead of v(plus,minus), this is to remind you that the signals do not cross zero, or get even close to it. L1.1 has about 167mV of non-zero crossing.
